**THE NATIONAL MARITIME MUSEUM ASSOCIATION**  
**Balclutha Deck Renewal Project**

**1997-1998  
Balclutha Deck Renewal Project**

**DAILY LOG**

**The present BALCLUTHA Main Deck Renewal Project**  
**began work in November of 1997 and lasted until June of 1998.**  
**The following photos and log are intended to chronicle the processes**  
**and results of this major restoration effort.**

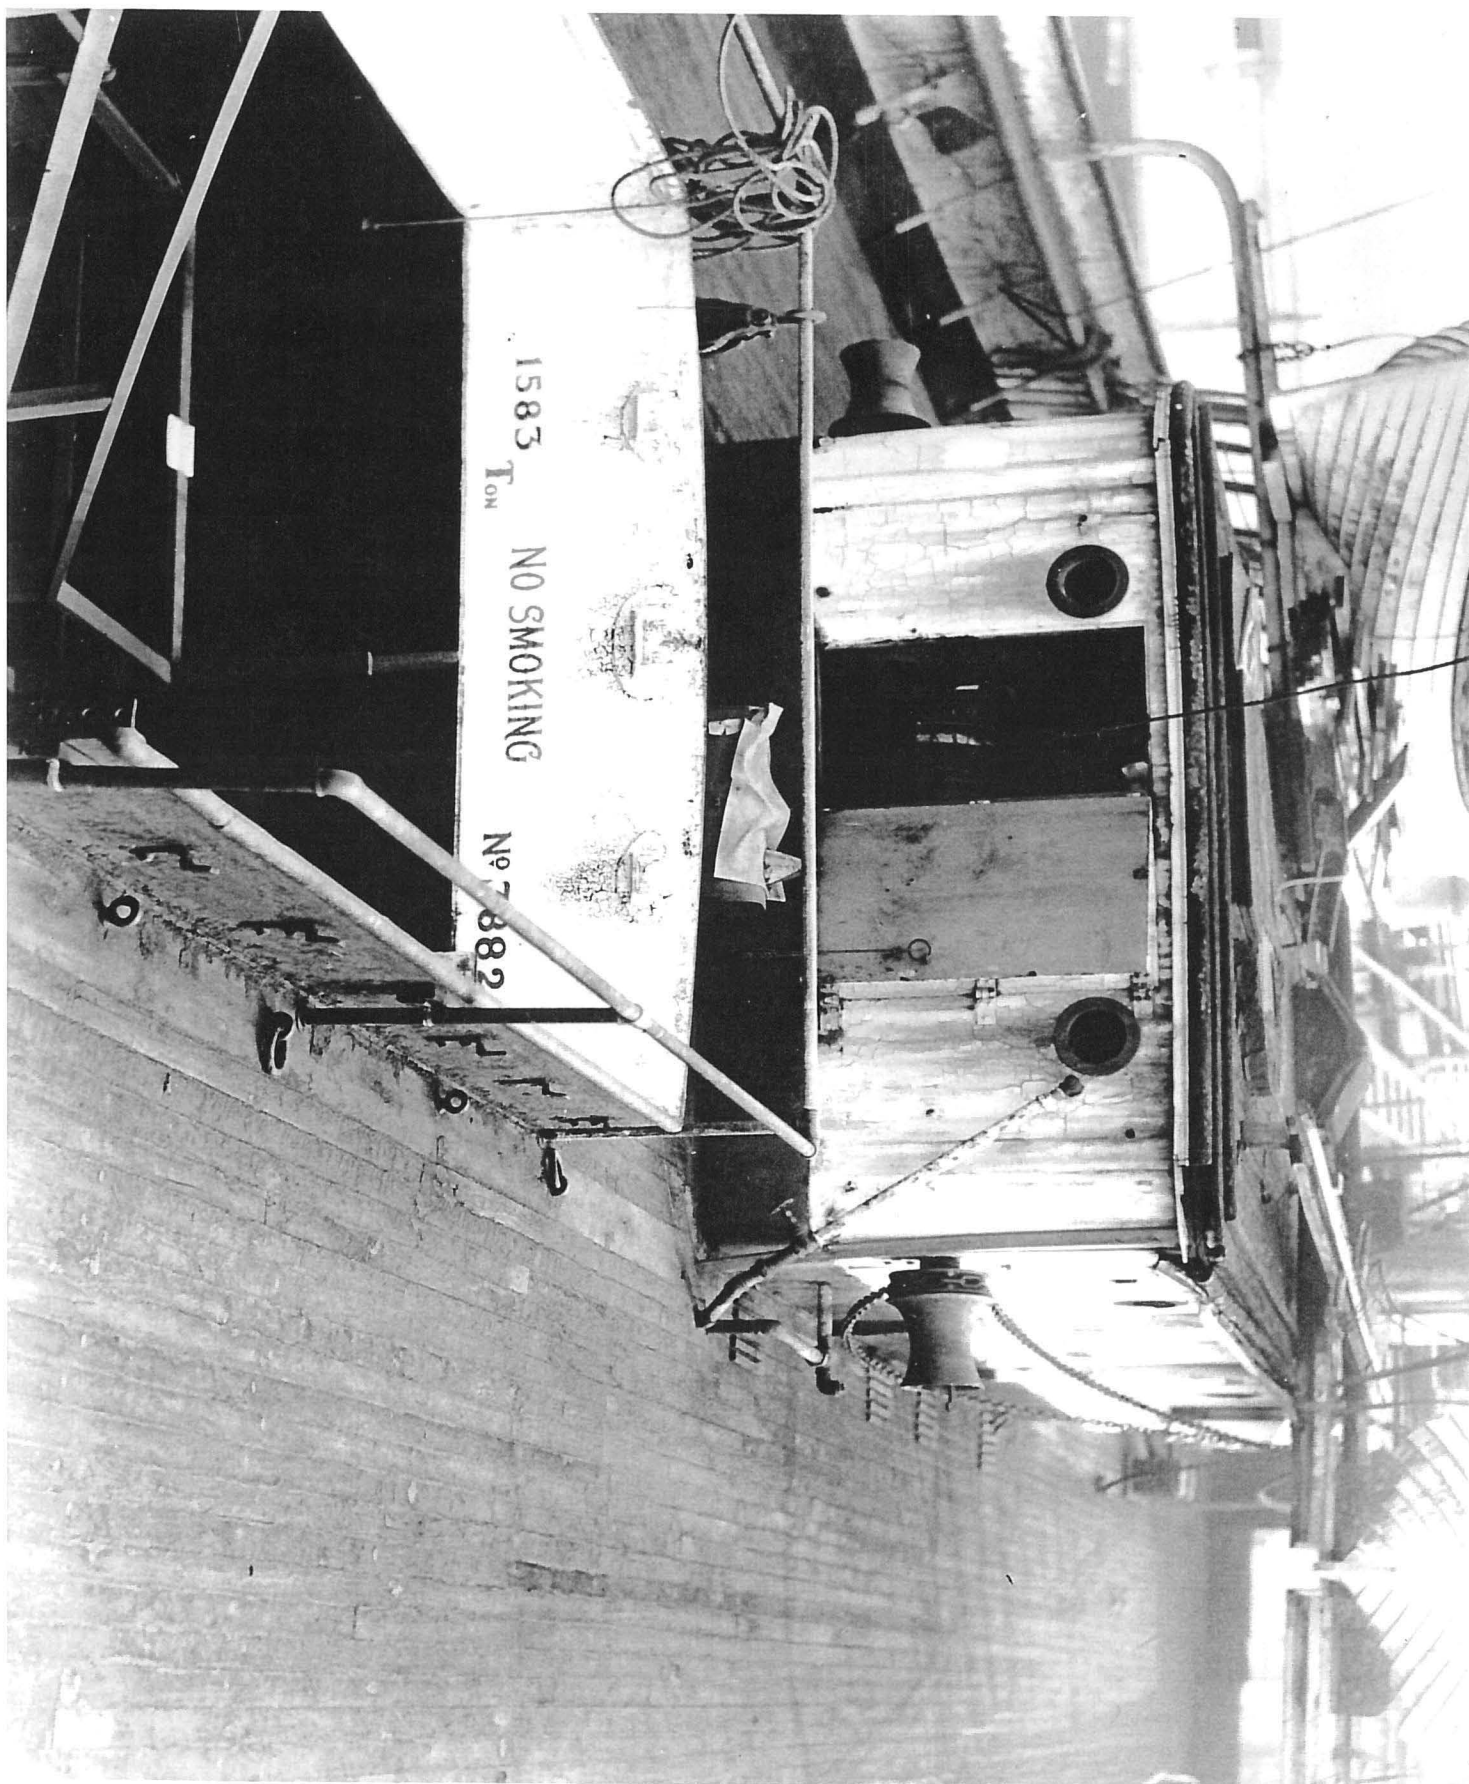
**PACIFIC QUEEN, 1947, possibly Long Beach.**

The after end combing of the main hatch was cut away sometime during her stint as an exhibition ship to make way for the stairs seen in this photo. The subsequent refitting left an obvious weld bead along the entire length of that section of hatch combing. Part of the present repair work to the main hatch includes fairing in the combing to replicate the original construction.

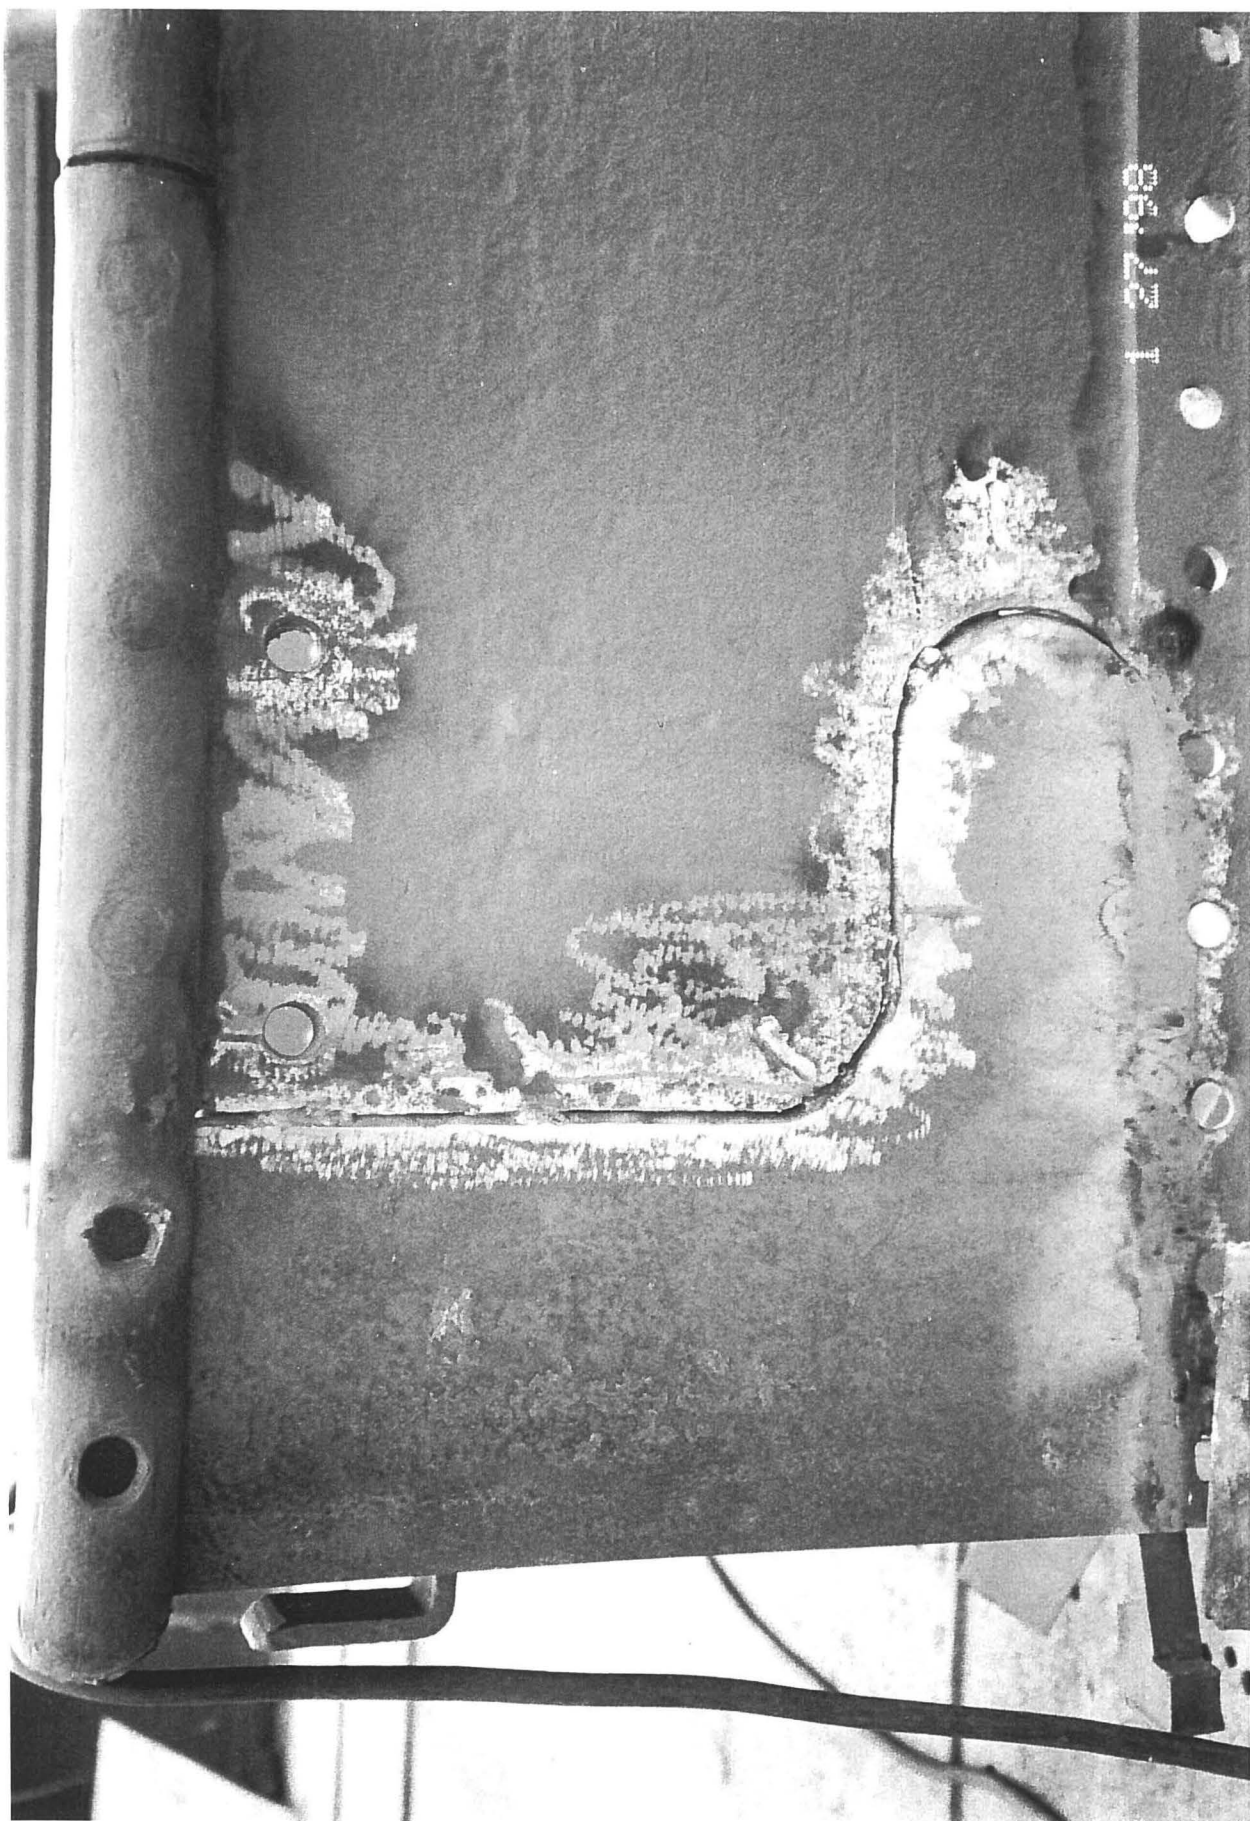
**Main Hatch Combing Repair Patch.**

A new steel plate was cut to fit where a corroded section was removed from the existing hatch combing. The insert pictured here was welded, faired in, painted and riveted to match the rest of the starboard side hatch combing.

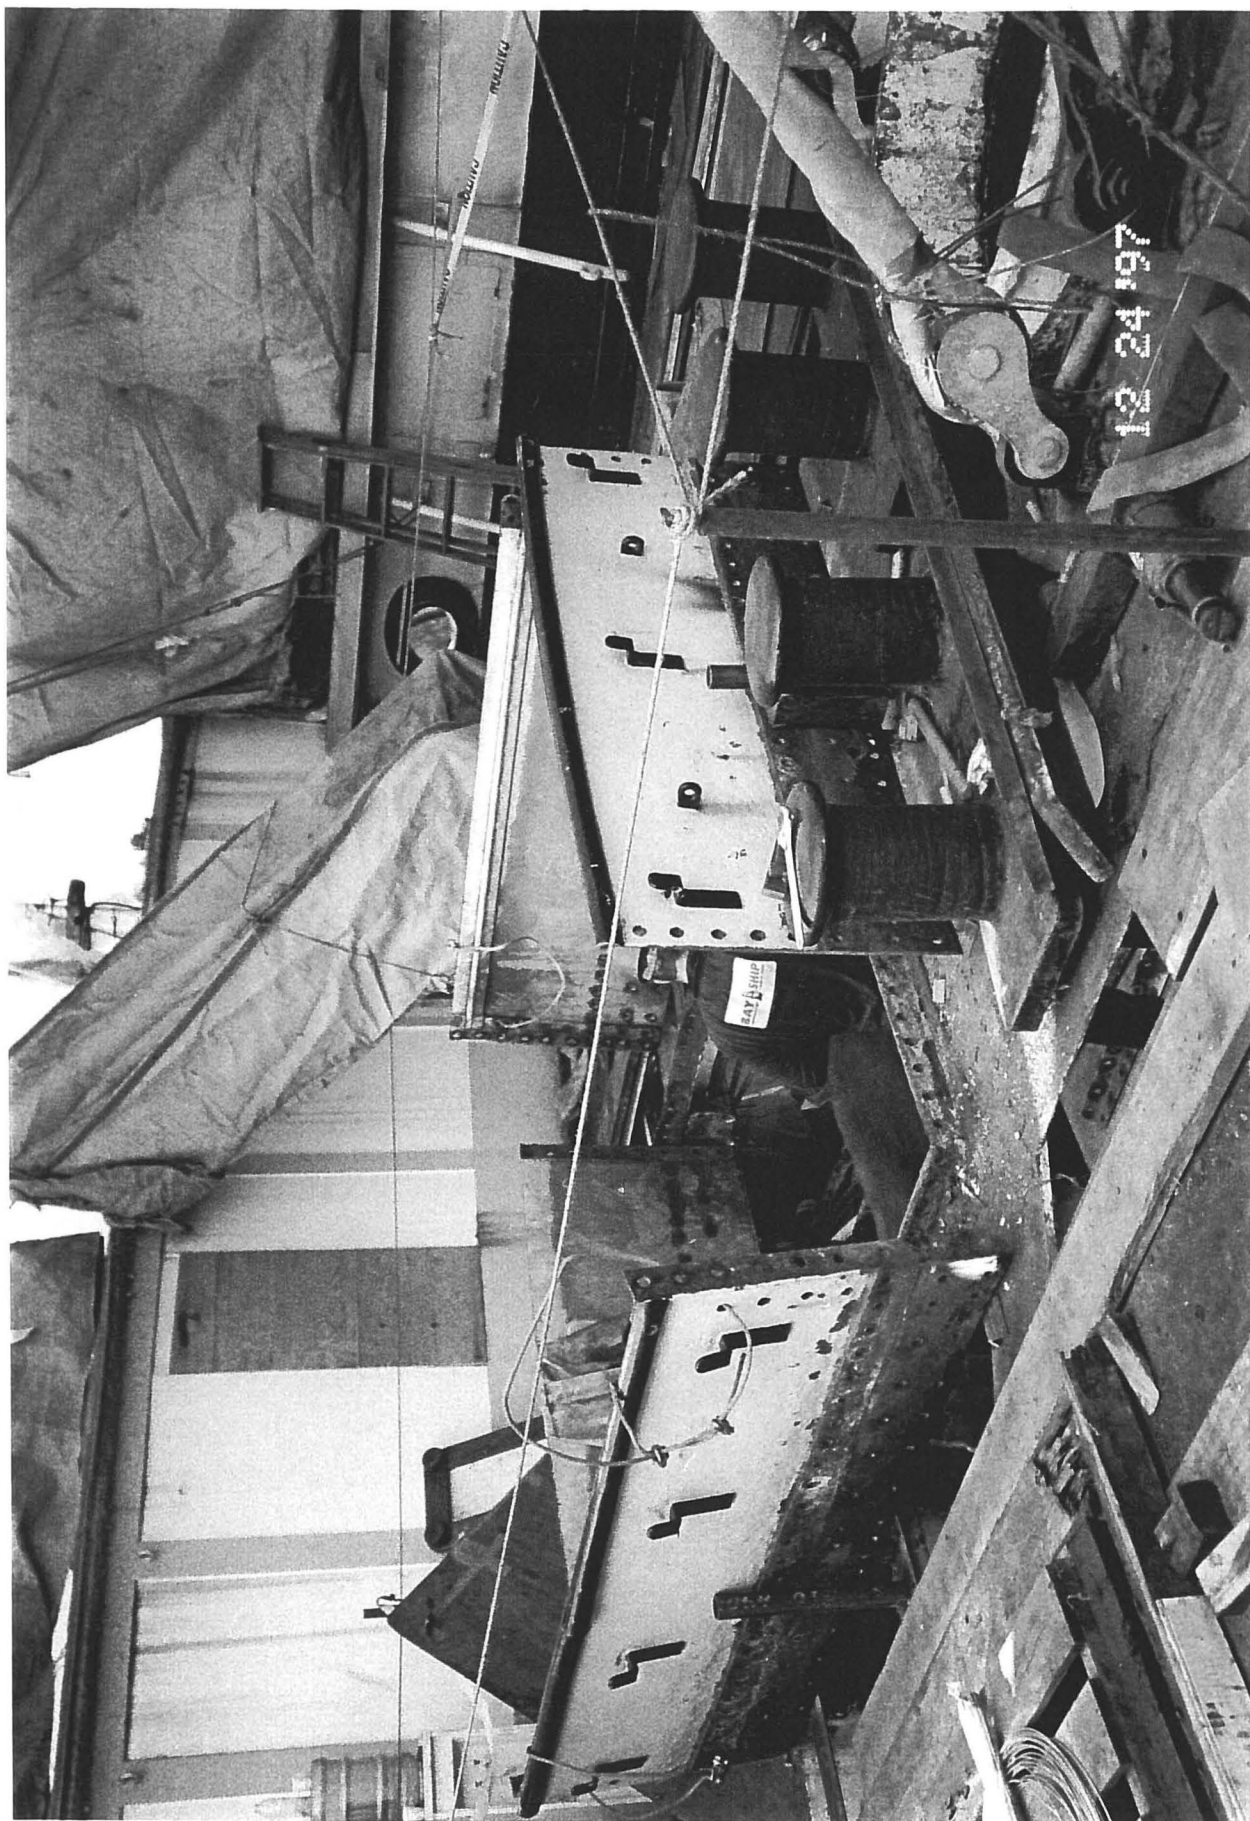
### **Forward Hatch Repair.**

Three sides of the forward hatch were completely disassembled to facilitate the necessary repairs. Most of the hundreds of original rivets that held the hatch combings together were found to be still binding the steel plates together with strong and watertight joints.

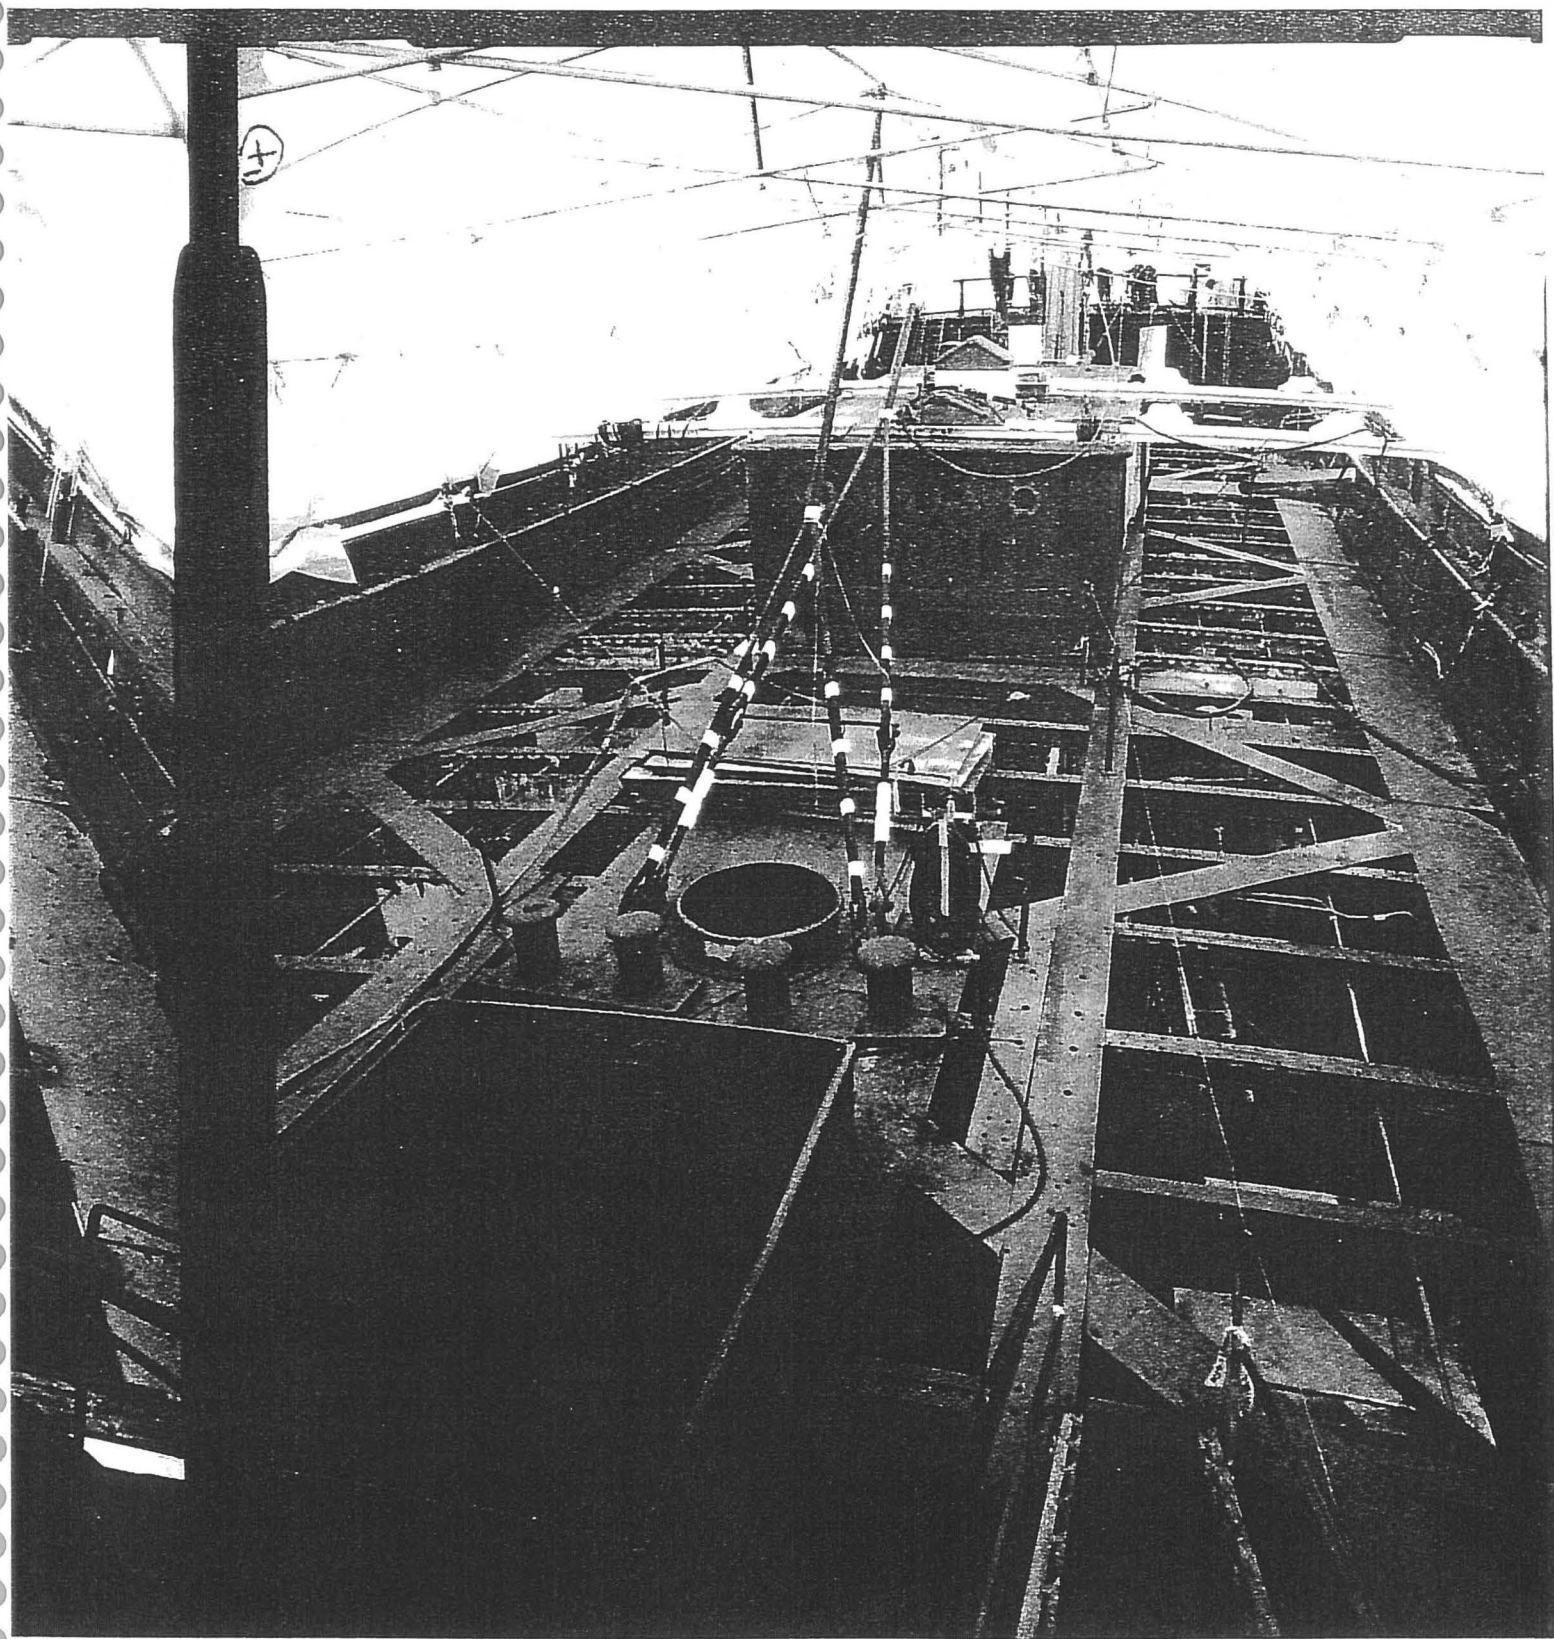
### **Weather Containment Structure.**

With the fore mast removed, the entire main deck area was enclosed in an aluminum and plastic containment structure during the work done alongside the dock. This containment was provided to protect the main deck from weather and to contain the sandblasting done on the main deck area. The winter of 1997-98 was one of the most severe rainy seasons the bay area had seen in over 100 years.

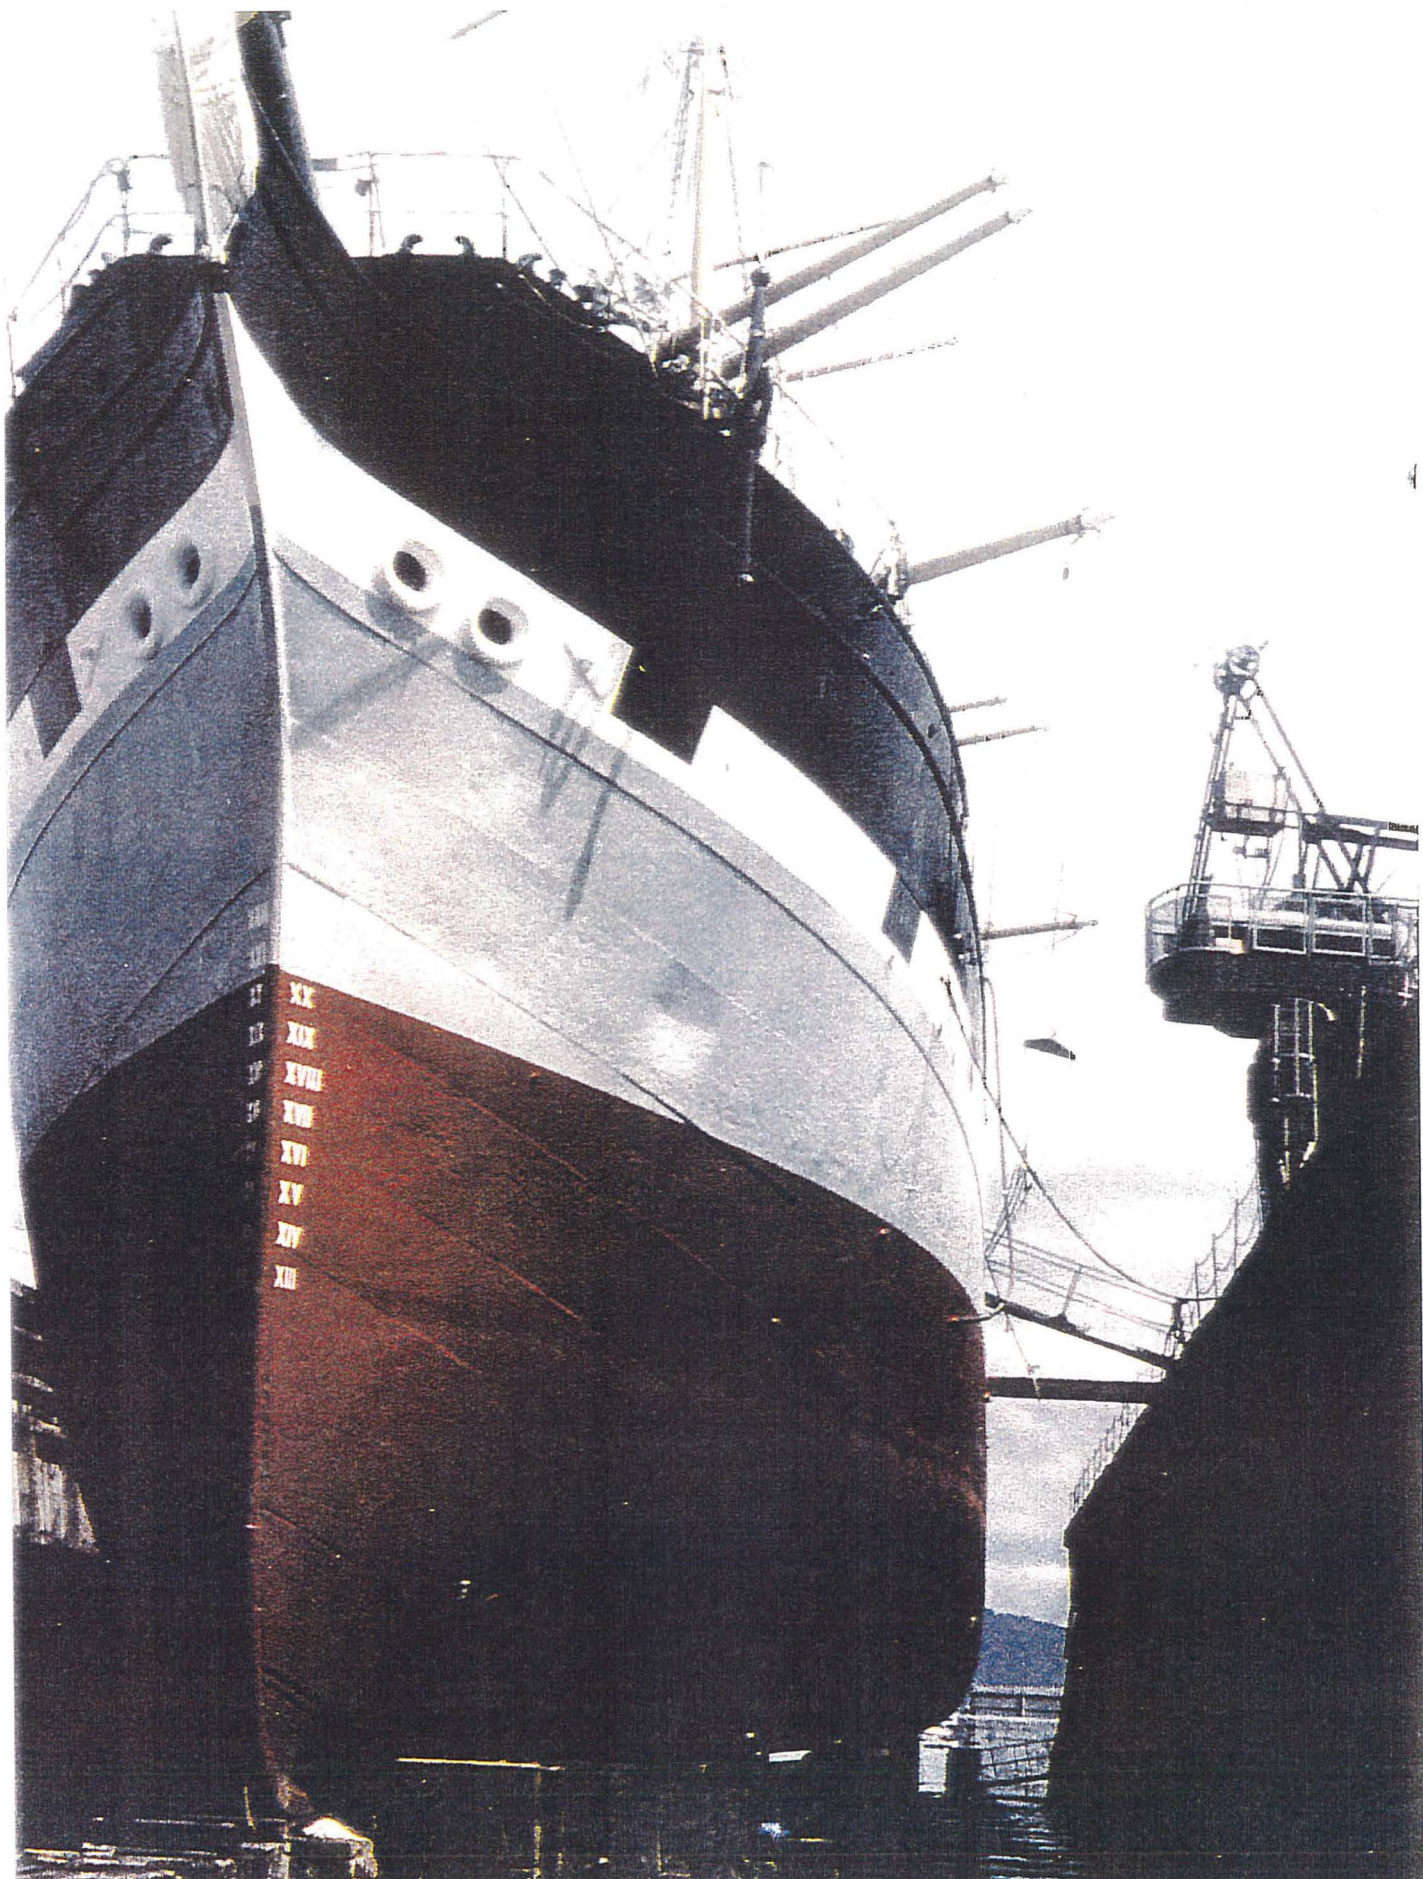
### **Brand New Bottom Paint**

With the steel repairs to the hull completed, the hull was painted with anti-corrosive primers, anti-fouling paints and advanced bottom paints to help keep the hull sealed and the entire exterior shipshape.

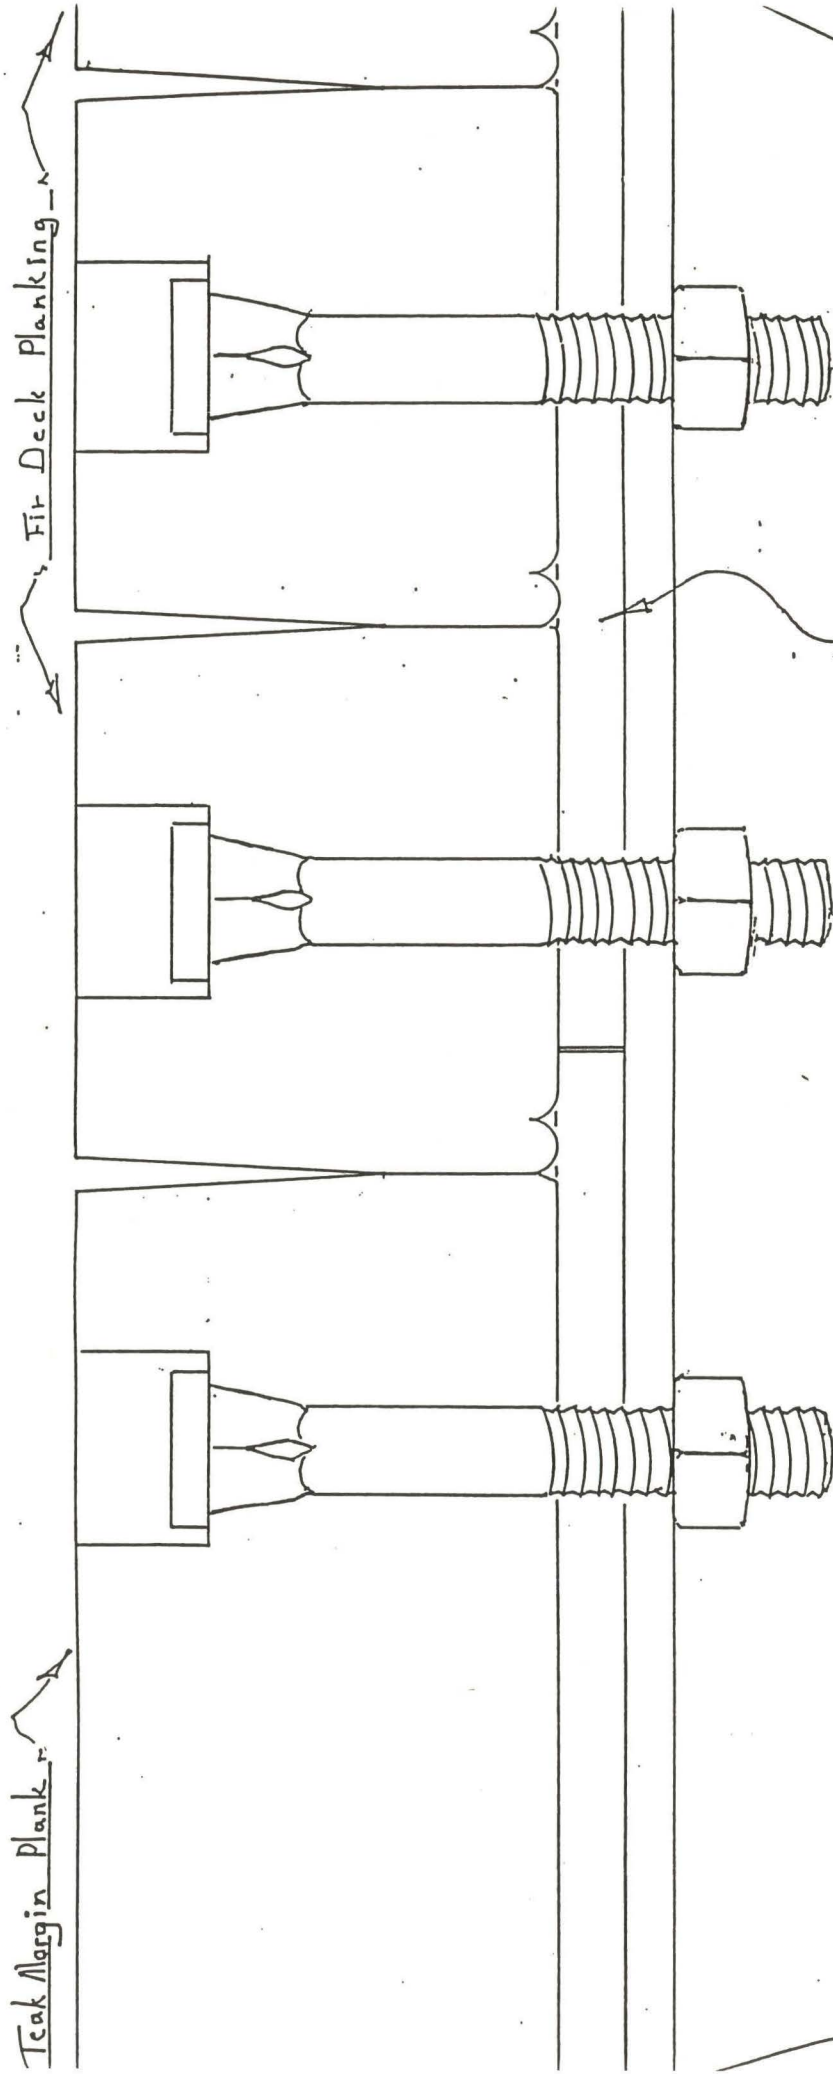
Yellow Cedar  
Fairing strips laid across  
uneven surfaces to help  
level deck planking

Deck Beam Below Decking
